**REPAIR OPTIONS**  
**FOR THE**  
**FEDERAL BREAKWATER**  
**EASTPORT, MAINE**

**MAY 20, 1994**

*Eastport Port Authority*  
P.O. Box 278  
Eastport, ME 04631

*Bourne Consulting Engineering*  
430 Franklin Village Drive  
Suite 145  
Franklin, MA 02038

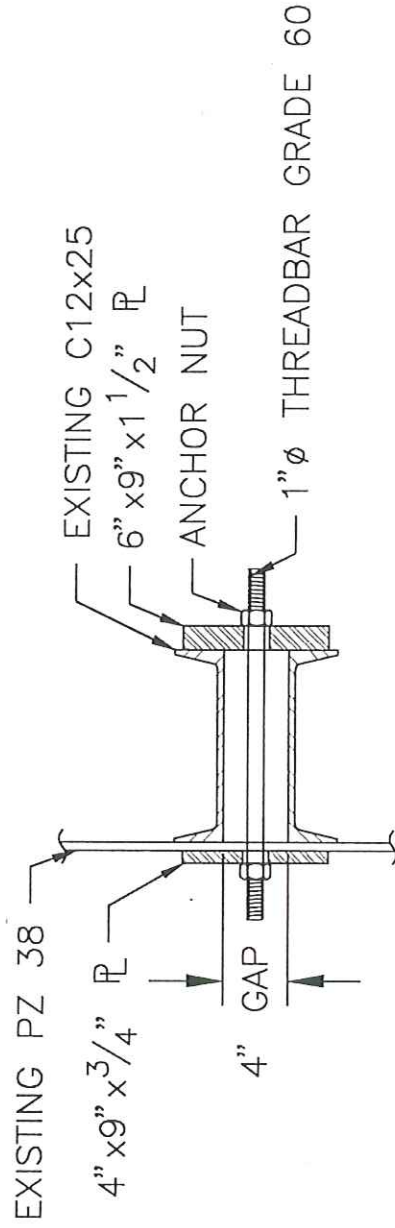
WALE CONNECTION @ EL +16.0

Inspection of the site revealed that a portion of the western side about mid-point along the 400 foot length had separated at El. +16 from the wale and an approximate 12 inch gap existed between the wale and the sheeting. This area had been excavated down to the wale and failure of wale to sheeting bolts was observed. The wale, although showing evidence of corrosion, was in good condition and the tie rod, where exposed, was found in good to excellent condition.

During the inspection of the bulkhead from the water side, a number of bolts were found missing at El. +16 along the section of failure that extends both north and south of this area. In discussions with the port manager, Brian Nutter, it was determined that several plates have also been lost at El. +4, but not as severe as is now being seen at El. +16.

At the present time, the failure of the bolts between the sheeting and wale are resulting in the sheeting moving away from the wale and a redistribution of the loads. Unfortunately, these loads are being redistributed down into the lower wale causing more stress in an area that may be in as poor condition as El. +16. At this time, it is strongly recommended that repairs begin immediately to reinstall the connection between the wale and the sheeting. A recommended repair detail would consist of an all thread bar with plate washers as shown in Figure 1. This would be installed at each pair of sheeting

connections. This work would require that excavation along the edge of the bulkhead take place down El. +16 to perform this work. Care should be made to not remove any of the existing wale to sheeting bolts unless they are already failed. The new connections should be installed as soon as possible.

DO NOT CUT EXISTING WALE/SHEET PILE CONNECTION BOLTS.  
REMOVE ONLY THOSE BOLTS THAT HAVE FAILED.

INSTALL 1 NEW BOLT @ EACH INDENT OF SHEETING. PLACE  
BOLT ON EITHER SIDE OF INTERLOCK.

TIE RODS SHALL BE CONTINUOUSLY THREADED AND SHALL  
CONFORM TO ASTM A615 (GRADE 60) AND SHALL BE FUSION  
BONDED EPOXY COATED, ALONG WITH ALL HARDWARE.

WHERE WALE HAS SETTLED, SECURE AREAS BEYOND SETTLEMENT  
AND THEN RAISE WALE TO ORIGINAL LOCATION.

WHERE CONTINUOUS GAP EXISTS BETWEEN WALE AND SHEETING  
EXCAVATE BELOW WALE AS FAR AS PRACTICABLE (MAX 6"). INSTALL  
NEW WALE/SHEETING CONNECTION AND TIGHTEN AS MUCH AS  
POSSIBLE WITHOUT DAMAGING WALE OR SHEETING.

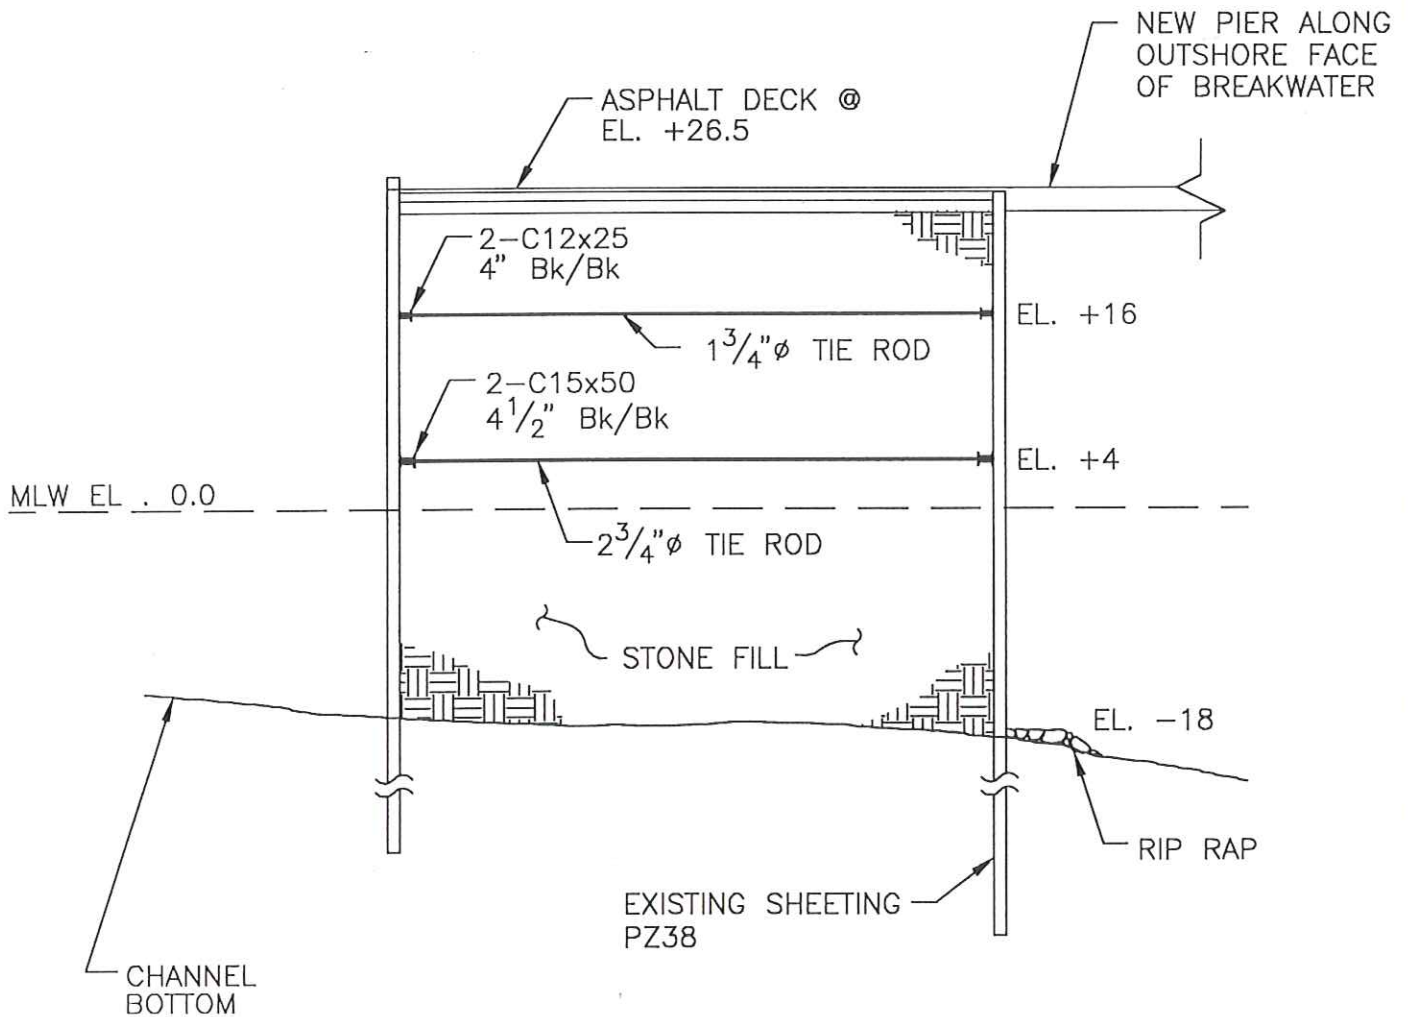
**EXISTING CONDITIONS**  
**TYPICAL SECTION**  
**FEDERAL BREAKWATER**

The existing breakwater consists of an approach that runs easterly from shore which is 40 feet wide. The bulkhead then extends to the south approximately 400 feet having a 50 foot width through this region. The steel sheet pile bulkhead has two rows of tie rods on the outer bulkhead at El. +4 and +16. It is this outer section of bulkhead running north/south that is exhibiting the problems with the sheeting to wale connection.

A second depression was seen on the western edge down at the southern end and a bowing of the sheeting was observed at that location. However, this condition has existed for some time and to the best of our knowledge, has never been excavated to determine the cause of the settlement.

The obvious recent problems with the bolt connections between the wale and the sheeting at El. +16 reveal that the structure's connections at this point are weakening and alternative or additional connections need to be made at this point. In addition, the existing sheet pile bulkhead has a number of holes which have developed within the zone of approximately El. -6 to El. +4 which have been documented in underwater inspections and which have been patched or plugged with concrete. It would appear that these conditions will continue until the structure can no longer stand. A long term repair would be required to resolve all these issues.
